**HORNSEY BROTHERS DAM
WASHINGTON COUNTY, MISSOURI
MO 30101**

PHASE 1 INSPECTION REPORT NATIONAL DAM SAFETY INSPECTION

NOVEMBER 1980

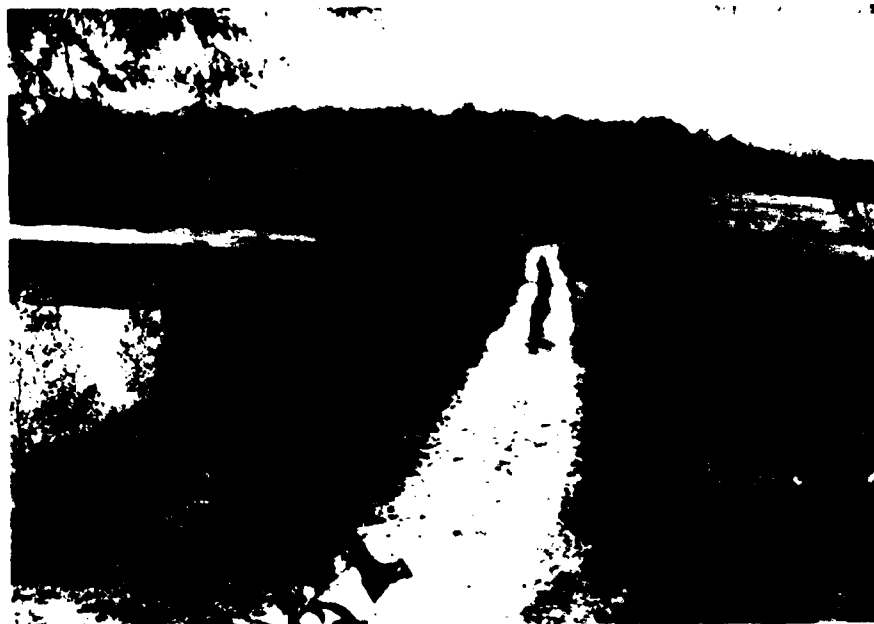
2. Roadway and dam crest from right abutment. Looking northwest. Note vegetation on upstream and downstream slopes.
